The Role of Sheikh Lotfollah Mosque's Buttresses in Prevention of its Thrust and Reasons for its Recent Re-thrust

Abstract

Keywords: Sheikh Lotfollah Mosque; Buttress; Pathology; Restoration

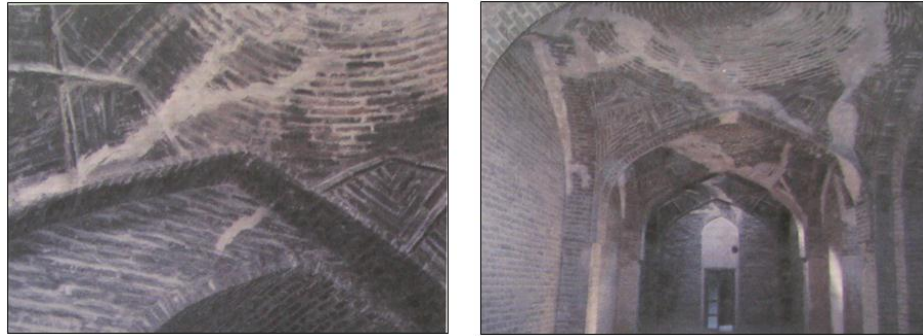
At that time, a thrust occurred in the north and northwest side of the building in a way that cracks with the width of 10 cm occurred in the vault of the floor under the porch, and 20 cm cracks were caused in second floor which would lead to the destruction of basement's yard and mosque's corridors. Master Maarefi believed the reason for this thrust was the existence of bath and its chimney's defect, so the action was taken to remove and eliminate these units (i.e., bathrooms and Turkish closet) and four strong brick buttresses were created behind the northern wall of the dome's porch (Beheshtian, 1976). The noteworthy point is that there are currently relatively large cracks in

the floor of the hallway, cracks and deformations in the north wall of the building despite the use of an element consistent with the structure (buttresses) and the proper restoration that took place at that time which has shown a good performance in less than a century (Figs 1 to 4). The question that comes to mind is that: how much the buttresses system affects the security level of bearing capacity in Sheikh Lotfollah Mosque? Can a positive trend be observed in performance of mosque's structural systems? Are there other affective factors in these deformations and cracks?

Fig 1 and 2 Cracks on the corridor of the second floor (Isfahan's Archives of Cultural Heritage)

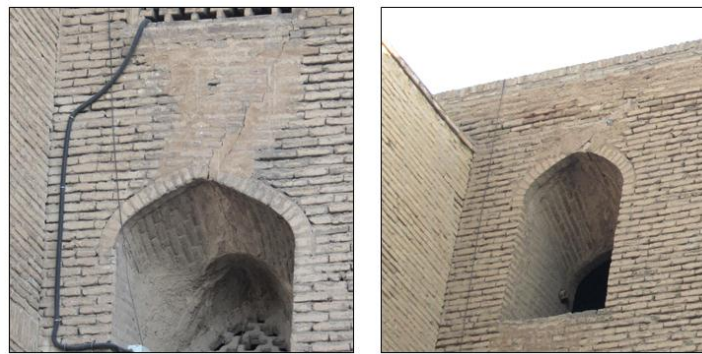
Fig 3 and 4 Cracks on the northern side of the mosque wall

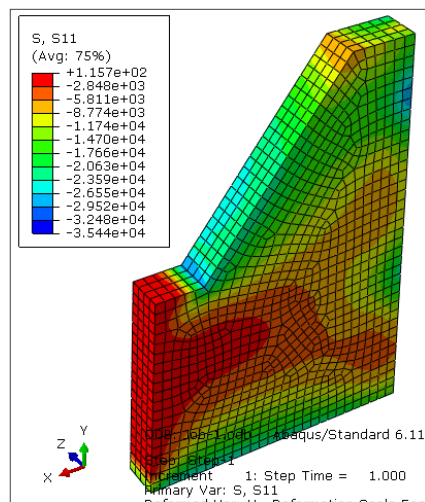
As shown in Fig 9, the maximum tensional and compressive strengths in simulated buttress are respectively 115.7 and 35440 Newton per meter squared which are acceptable compared to allowed tensional and compressive strengths in used materials (table 2).

Fig 9 Tensional and Compressive contour stresses in modeled buttress without the load of dome

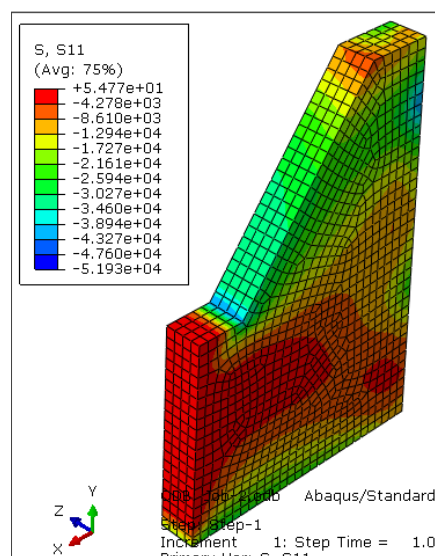
The thrust force caused by the dome was also added to previous forces in the modeling and the model was implemented again in order to have more reliable results. Not only has the buttress showed a positive response in the mode, but also tensional and compressive strengths do not exceed the limit until 1.2 time bigger force (Fig 10).

According to fig 10, it can be stated with confidence that the volume of used materials and the dimensions of buttresses are relatively high for transformation of thrust force and smaller buttresses with smaller dimensions would be able to bare the applied forces. In this regard, the buttresses with opening were also capable of meeting the demands of the architect and a prominent example of which is the great mosque of Yazd.

Based on the mentioned presentations, high volume and weight of buttresses will lead to subsidence of the building which indicates the theory of creation of cracks or deformation. But nearly a century passes from the construction of these walls and the subsidence is in fact a consolidation subsidence in the building which has reached to a balance at the moment. The question which can be posed is that: what is the cause of created crack and deformation? This will be discussed in the next section.

Fig 10 Tensional and Compressive contour stresses in modeled buttress with the load of dome

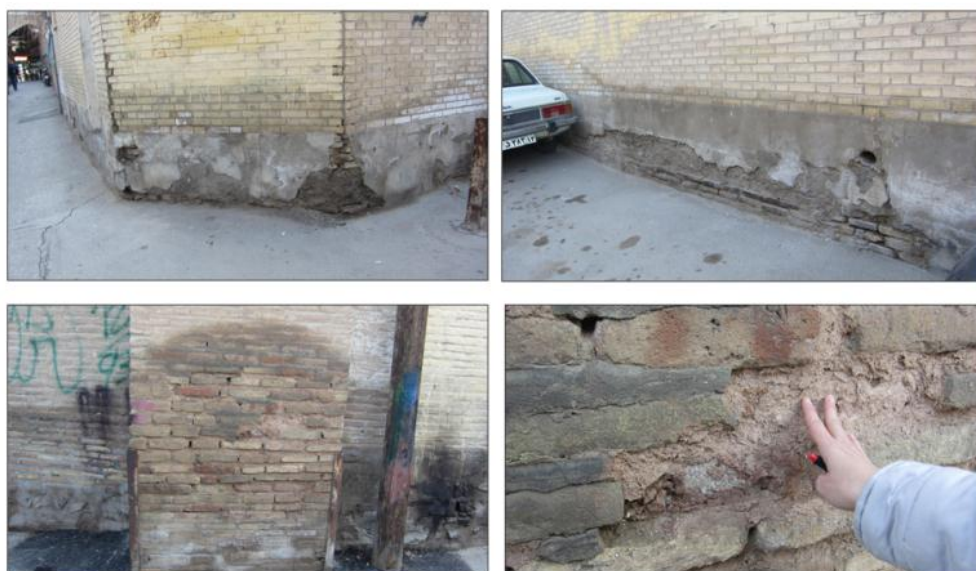
The caries, corrosion and moisture in buildings in the sides of mosque's adjacent streets (Photo 5 to 8) made authors to search for an external harmful factor out of the mosque's building. The ascending moisture of sewer and water pipes leaking in the studied area were identified to be the causes of damage in conducted research and studies. According to water and sanitation experts, the design of the existing sewer plumbing in the mentioned alley is related to 1971 and its implementation has been carried out in 1972 with an inner diameter of 250 mm and a depth recorded in Fig 11 which are estimated to date back to 40 years ago and have not been reconstructed or replaced in this time period. Given that this time period is a long time compared to regional standards in a way that the determined standard in Middle East countries is 6 years and up to 17 year in Europe and their replacement, repairing and reconstruction are necessary after this time (Naddafi and Dindarlu, 2003). On the other hand, according to concluded studies: "Leakage of sewage networks in Iran is averagely nearly 59 percent in different areas every 24 hours" (Asadiany Yekta and Tabesh, 2010) which is a significant amount. It can be argued using this interpretation and with the population growing in recent years that the sewage pipes in the area under evaluation have been eroded and damaged.

Photo 5 to 8 Caries, corrosion and moisture in buildings in the sides of mosque's adjacent streets

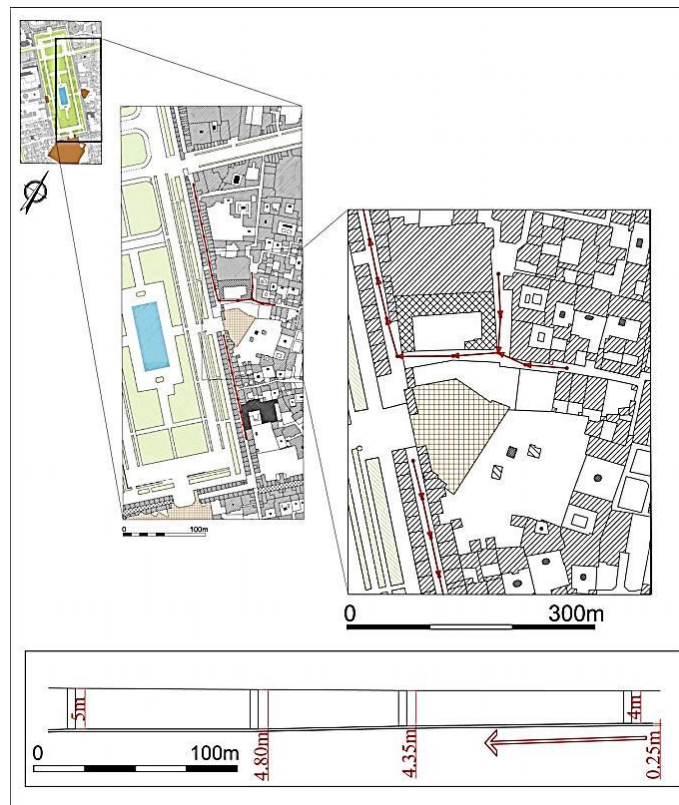
Fig 11 Tilt and depth of the sewer pipes in the mosque's adjacent alley

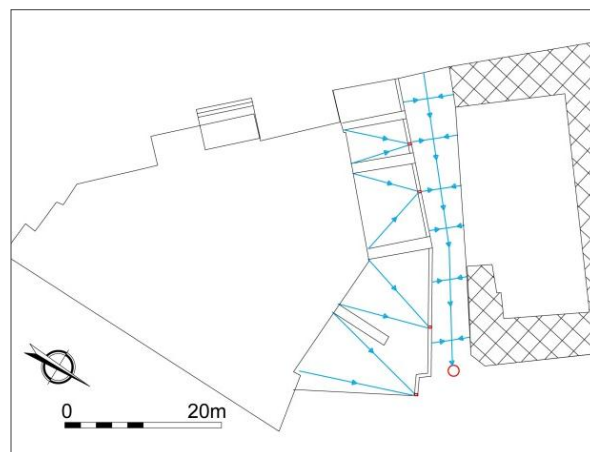
Since the brick paving of this part has been completely destroyed and this will absorb water and moisture during rain and directs water and moisture to the lower part of the wall, all of the brick paving of this part must be collected and the area be paved by applying the correct slop and blocked waterways in this area be opened again in order to easily direct running water from drains to the alley. The slope of this part should also be directed to the alley in order to let water of rainfall to slip on the created surface and be directed to the area. The slope of the area has been shown in Fig 18.

Fig 18 Slope of buttresses area and the alley
