The Role of Sheikh Lotfollah Mosque's Buttresses in Prevention of its Thrust and Reasons for its Recent Re-thrust

Abstract

Keywords: Sheikh Lotfollah Mosque; Buttress; Pathology; Restoration

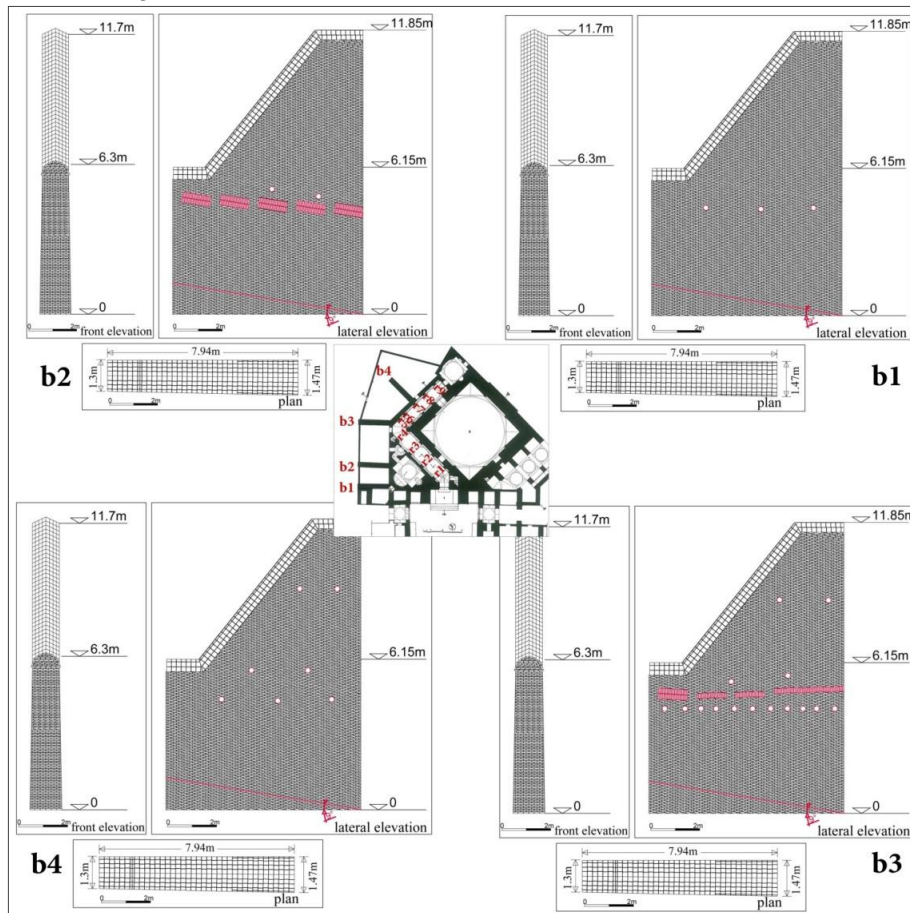
Fig 6 Plan, front elevation and side elevation of buttresses of Sheikh Lotfollah Mosque

The mentioned buttresses are solid buttresses with trapezoidal plan in size of $1.47 \times 1.3 \times 7.94$ meters and combined section (rectangle, triangle) which are clearly visible in Fig 6. Their height is 11.85 meters which are 60 cm lower than the building's roof. The section of the buttress increases by 1.5 meters at the height of 6.15 meters (the place where the roof of first floor's hallway is located) which is certainly because of thrust force of this section's vaults and increasing confidence

coefficient in the structure (Fig 7). The b1 and b2 buttresses are located in along second floor and the roof's entrance hallway's main piers and b3 buttress is located along the twist of the main corridor and b4 buttress has been embedded behind the main corridor after the twist along r7 rib. The surfaces of buttresses have been constructed with bricks with dimensions of $20 \times 20 \times 5$ cm with slope for directing rain and snow.

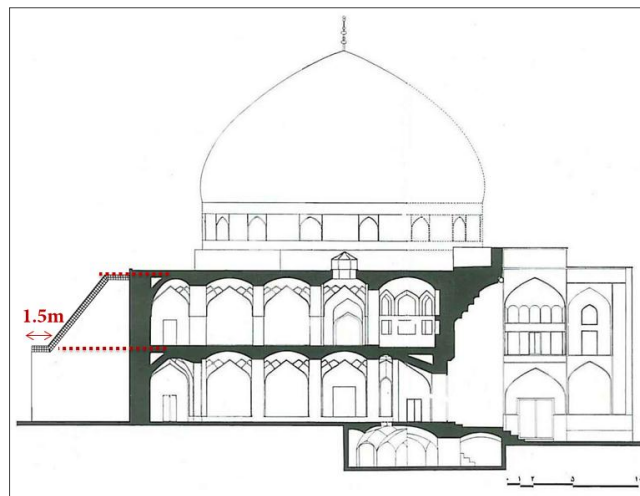
Fig 7 Increase section of the buttress where the roof of first floor's hallway is located (Isfahan's Archives of Cultural Heritage)

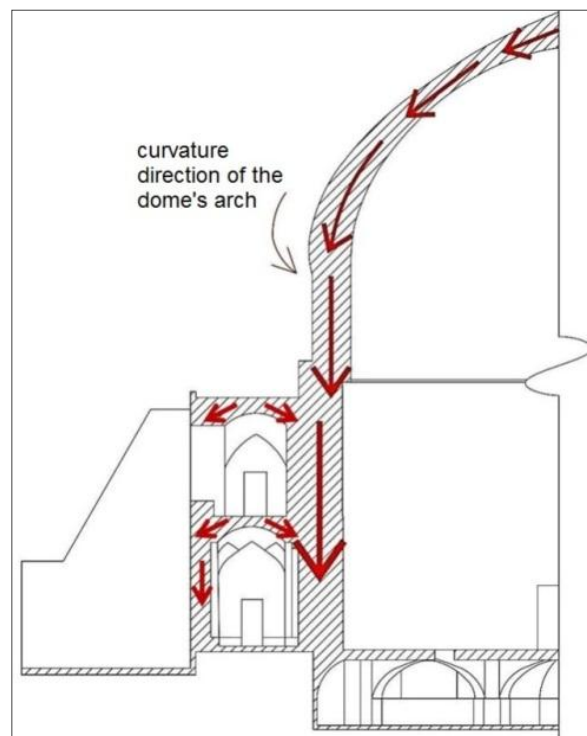
In the second step, information was simulated in the software. Although the single-shell dome of Sheikh Lotfollah Mosque is considered to be a dormant dome and exerts a huge thrust force but the skillful architect has been able to control thrust force with extremely low curvature of dome's bottom into the craters and designing thicken walls and two floor corridor in west and north of the mosque.

In this case, Ackerman and Pope believe that: “the dormant curvature of the dome leads to increased thrust in Oguns, but this force has been solved by increasing the thickness of walls” (Pope and Ackerman, 2008). Hejazi has also analyzed the dome of Sheikh Lotfollah Mosque using ANSYS software and expresses in this regard that: “applied tensional, compressive and shear strengths to the dome, do not pass the authorized strengths” (Hejazi, 1997). Thus it can be argued that the thrust force applied to the buttresses are not coursed by thrust force and the thrust force caused by the weight of corridors' roof (vaults and ribs) has been calculated without consideration of dome's load in order to apply thrust force in the simulated model. The force distribution in the dome can be seen in Fig 8.

Fig 8 Force distribution and its transformation to the ground in the dome of Sheikh Lotfollah Mosque

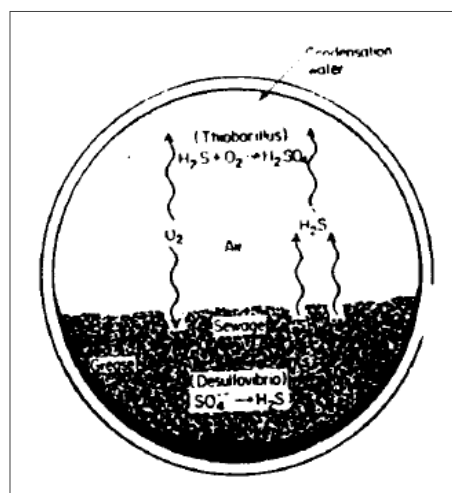
H₂S gas enters the upper atmosphere of sewer pipes due to turbulence and the presence of moisture and oxygen provides the sulfur by oxidizing bacteria for the oxidation reaction of H₂S gas. As a result, the produced sulfuric acid will cause the concrete corrosion by dissolution of calcium carbonate in the concrete. Fig 12 shows the stages of H₂S gas production in sewer pipes (Naddafi and Dindarlu, 2003).

Fig 12 Method of H₂S gas production in sewer pipes and corrosion (Naddafi and Dindarlu, 2003)

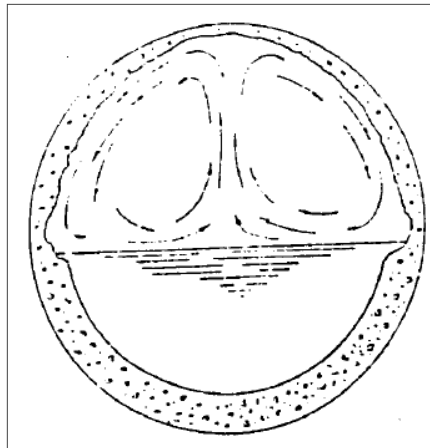
Based on the observations of corroded pipes, the corrosion is not limited to the pipe's crown and it also attacks the sides of pipes. The rate of corrosion on the left side of the pipe has been reported to be higher than other parts in calculations (Fig 13) (Naddafi and Dindarlu, 2003).

Fig 13 No equilibrium distribution of corrosion in concrete sewer pipes (Naddafi and Dindarlu, 2003)

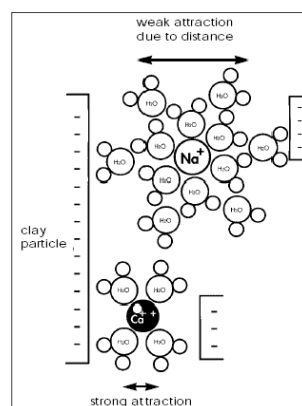
The sewer pipe corrosion will definitely lead to leakage and penetration of salts and water the soil around the pipes. On the other hand, cations of the salts sewer pipes, absorb dipole molecules of water (Fig 14) and increases the level of soil's water absorption level. The dipole molecules of water rise up in form of capillary along with negative ions in the soil and positive evaporation occurs on the wall surface and negative ions will precipitate. The accumulation of negative loads on the surface of the wall and positive loads in the soil creates load potential difference in soil. This potential difference will cause more water to rise in the form of capillary with higher suction and increase the level of moisture in the soil and increase the possibility of having saturated soil (Massari, 1997) and this moisture will intensify the damage.

Fig 14 Absorption of water's dipole molecules in soil to existing Cations in sewage pipes' salts (Dos, 1993)
